Please find attached our Liner Damage Assessment, Repair and CQA Report for recent repairs on the MSW Cell E6 Sideslope Liner. Also attached is a figure showing the recommended MSW filling area in Cell E6.

Subject: Liner Damage Assessment, Repair, and Construction Quality Assurance Report
for Cell E6 Sideslope, Waimanalo Gulch Sanitary Landfill, Kapolei, HI

Figure 1
MSW Cell E6 Sideslope
Liner Damage Areas

Waste Management of Hawaii
Waimanalo Gulch Sanitary Landfill
Kapolei, Oahu, Hawaii

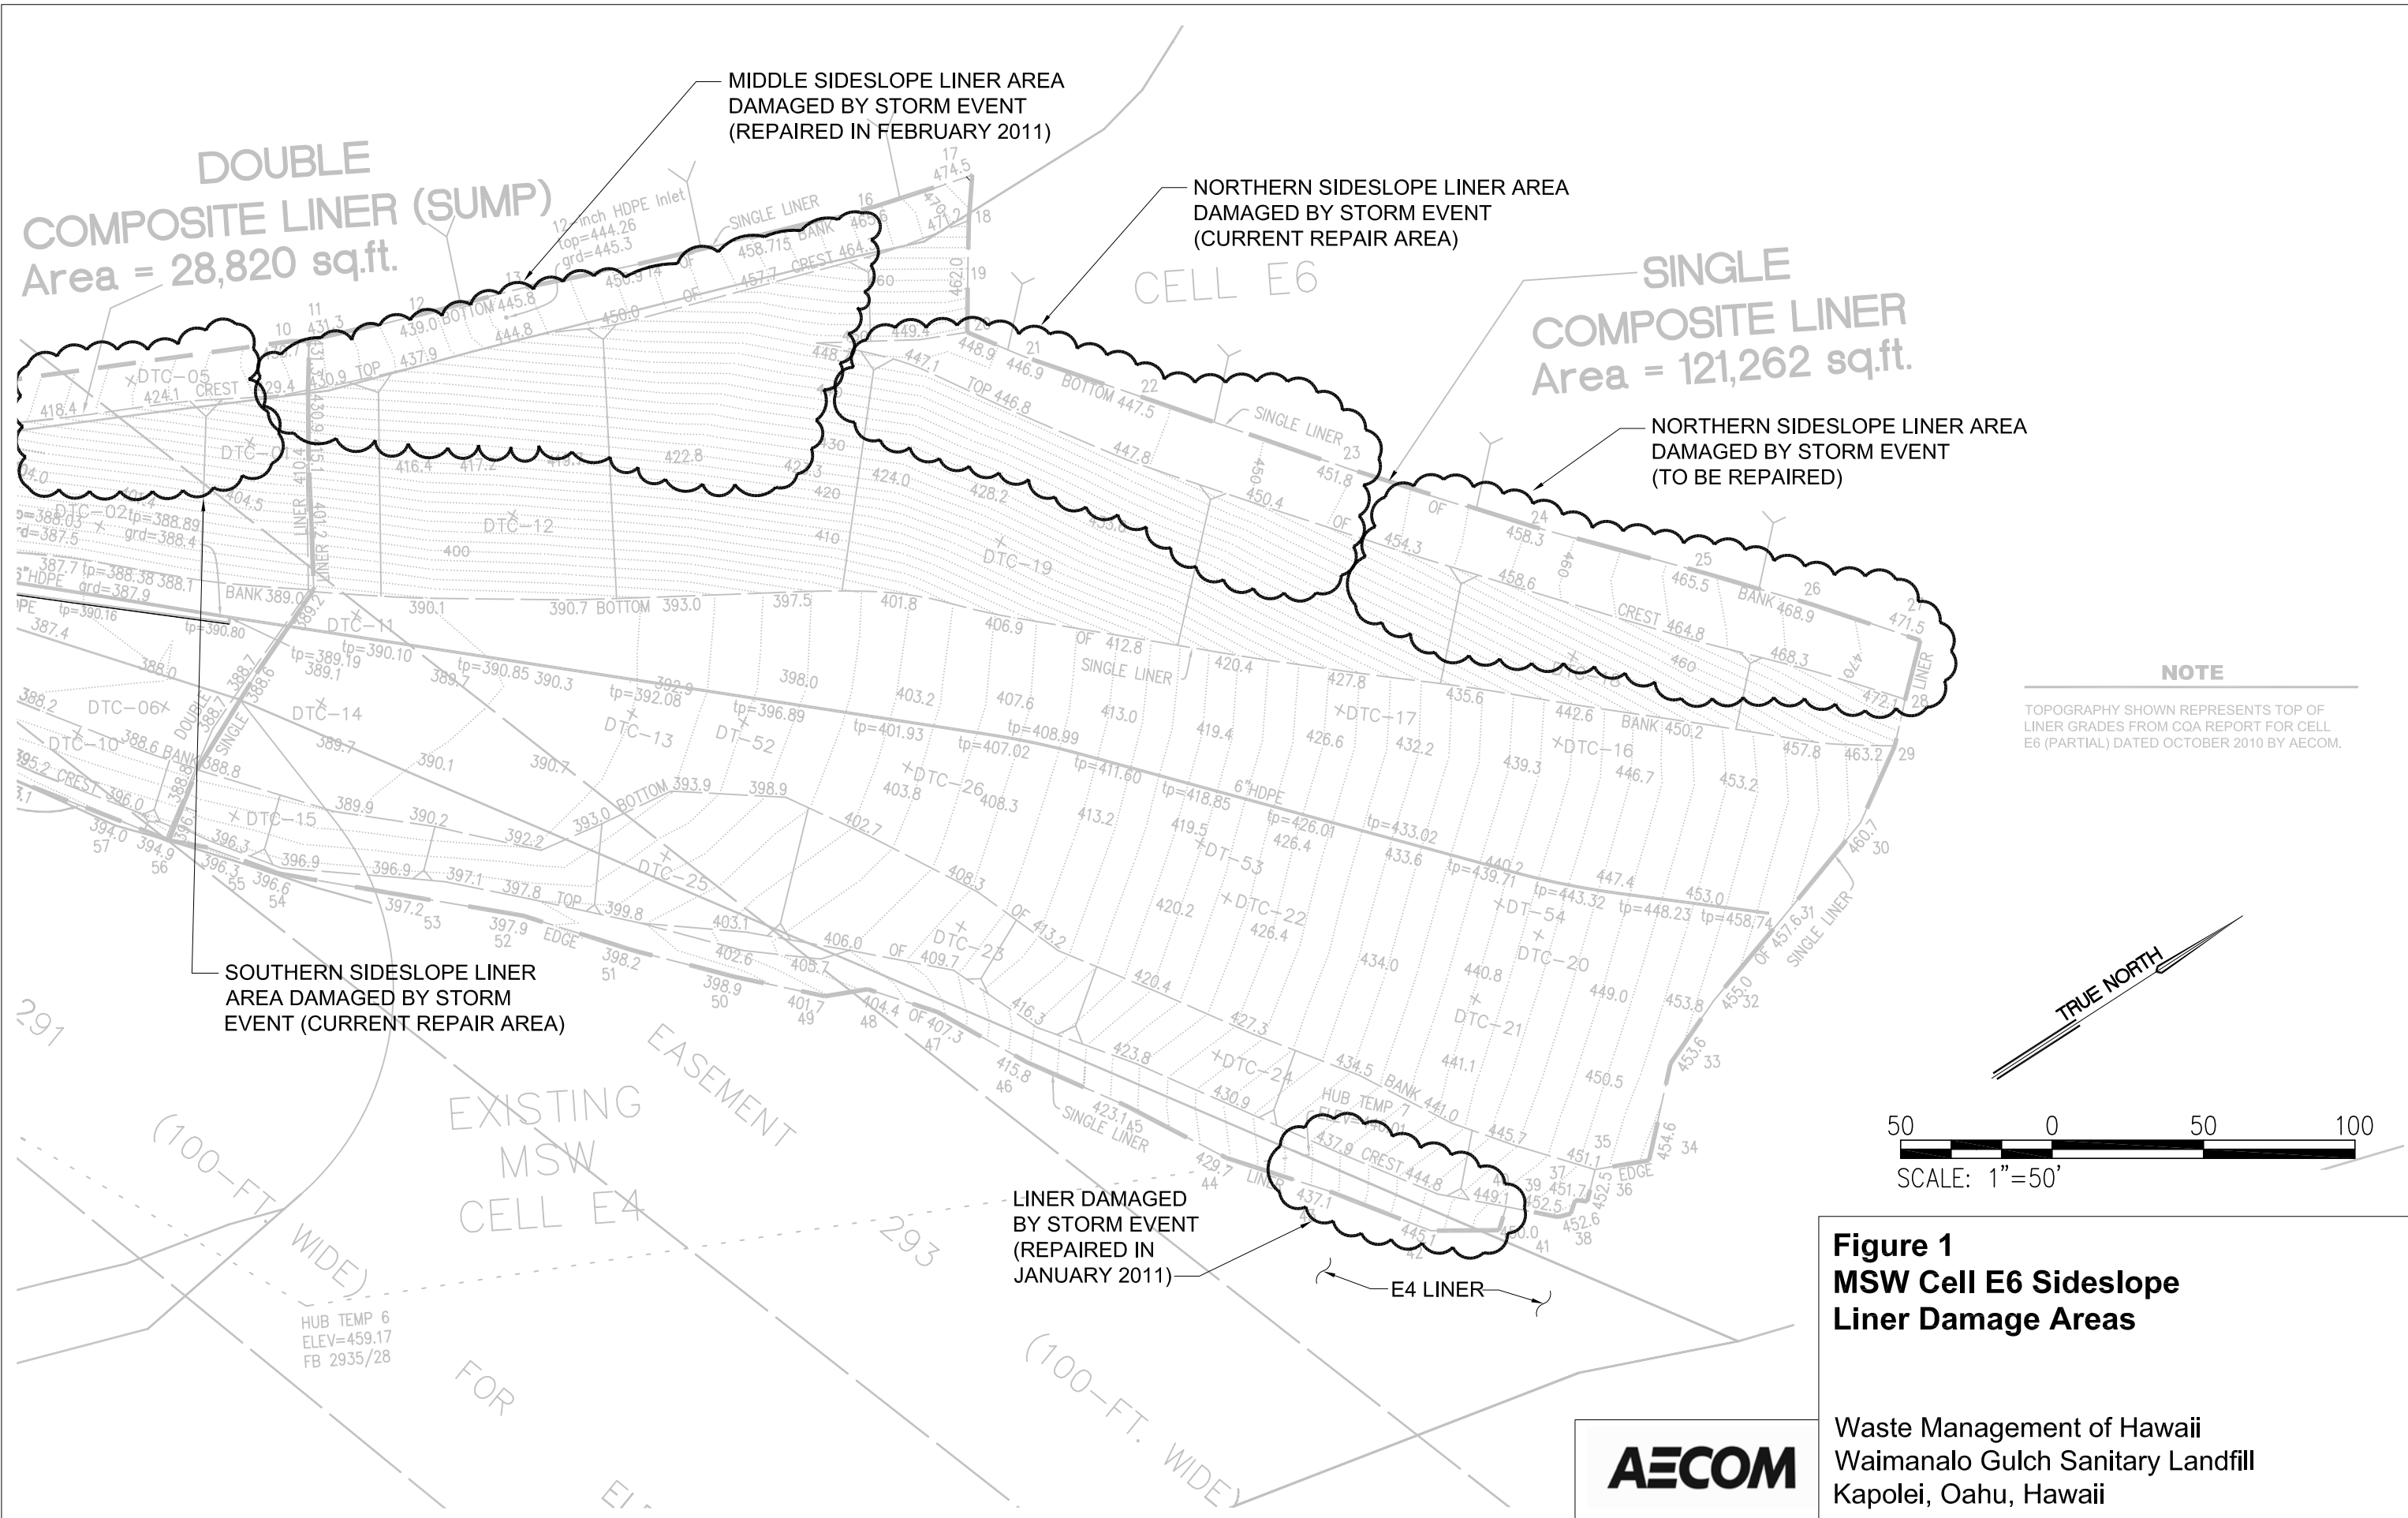
In late December 2010, a series of storms produced high run-on at the site resulting in damage to the northeastern edge of the MSW Cell E6 liner where it joins with Cell E4. Another large storm arrived on the evening of January 12, 2011 that resulted in additional flooding of the landfill and damaged the exposed portion of the western sideslope area of the MSW Cell E6 liner system. The damaged areas and repairs completed to date are shown on Figure 1, Attachment 1.

This letter report focuses on repairs to the southern and northern portions of the Cell E6 liner sideslope (see Figure 1), along the western edge of Cell E6. Approximately fifty percent of the northern sideslope damaged area has been repaired and is documented in this report. The remaining area (northern half) is currently being repaired and will be documented in separate report. This Liner Damage Assessment, Repair, and Construction Quality Assurance Report follows requirements established in the *Workplan for Liner Evaluation and Repair* prepared by Geosyntec Consultants, Inc. dated January 27, 2011.

The high water flows during the storm event resulted in erosion of the operations layer soils on the termination bench and sideslope areas, thereby exposing the liner to subsequent damage by falling rocks. Additionally, the lack of anchor soil on the termination bench over the liner resulted in movement of the liner that created wrinkles. Due to numerous holes in the exposed sideslope liner at the northern end of the cell caused by falling rocks, water and sediment were able to flow between the geotextile, 60-mil geomembrane, and geosynthetic clay liner (GCL) layers. Portions of the GCL of the sideslope area were hydrated and covered with sediment due to the water and sediment flow.

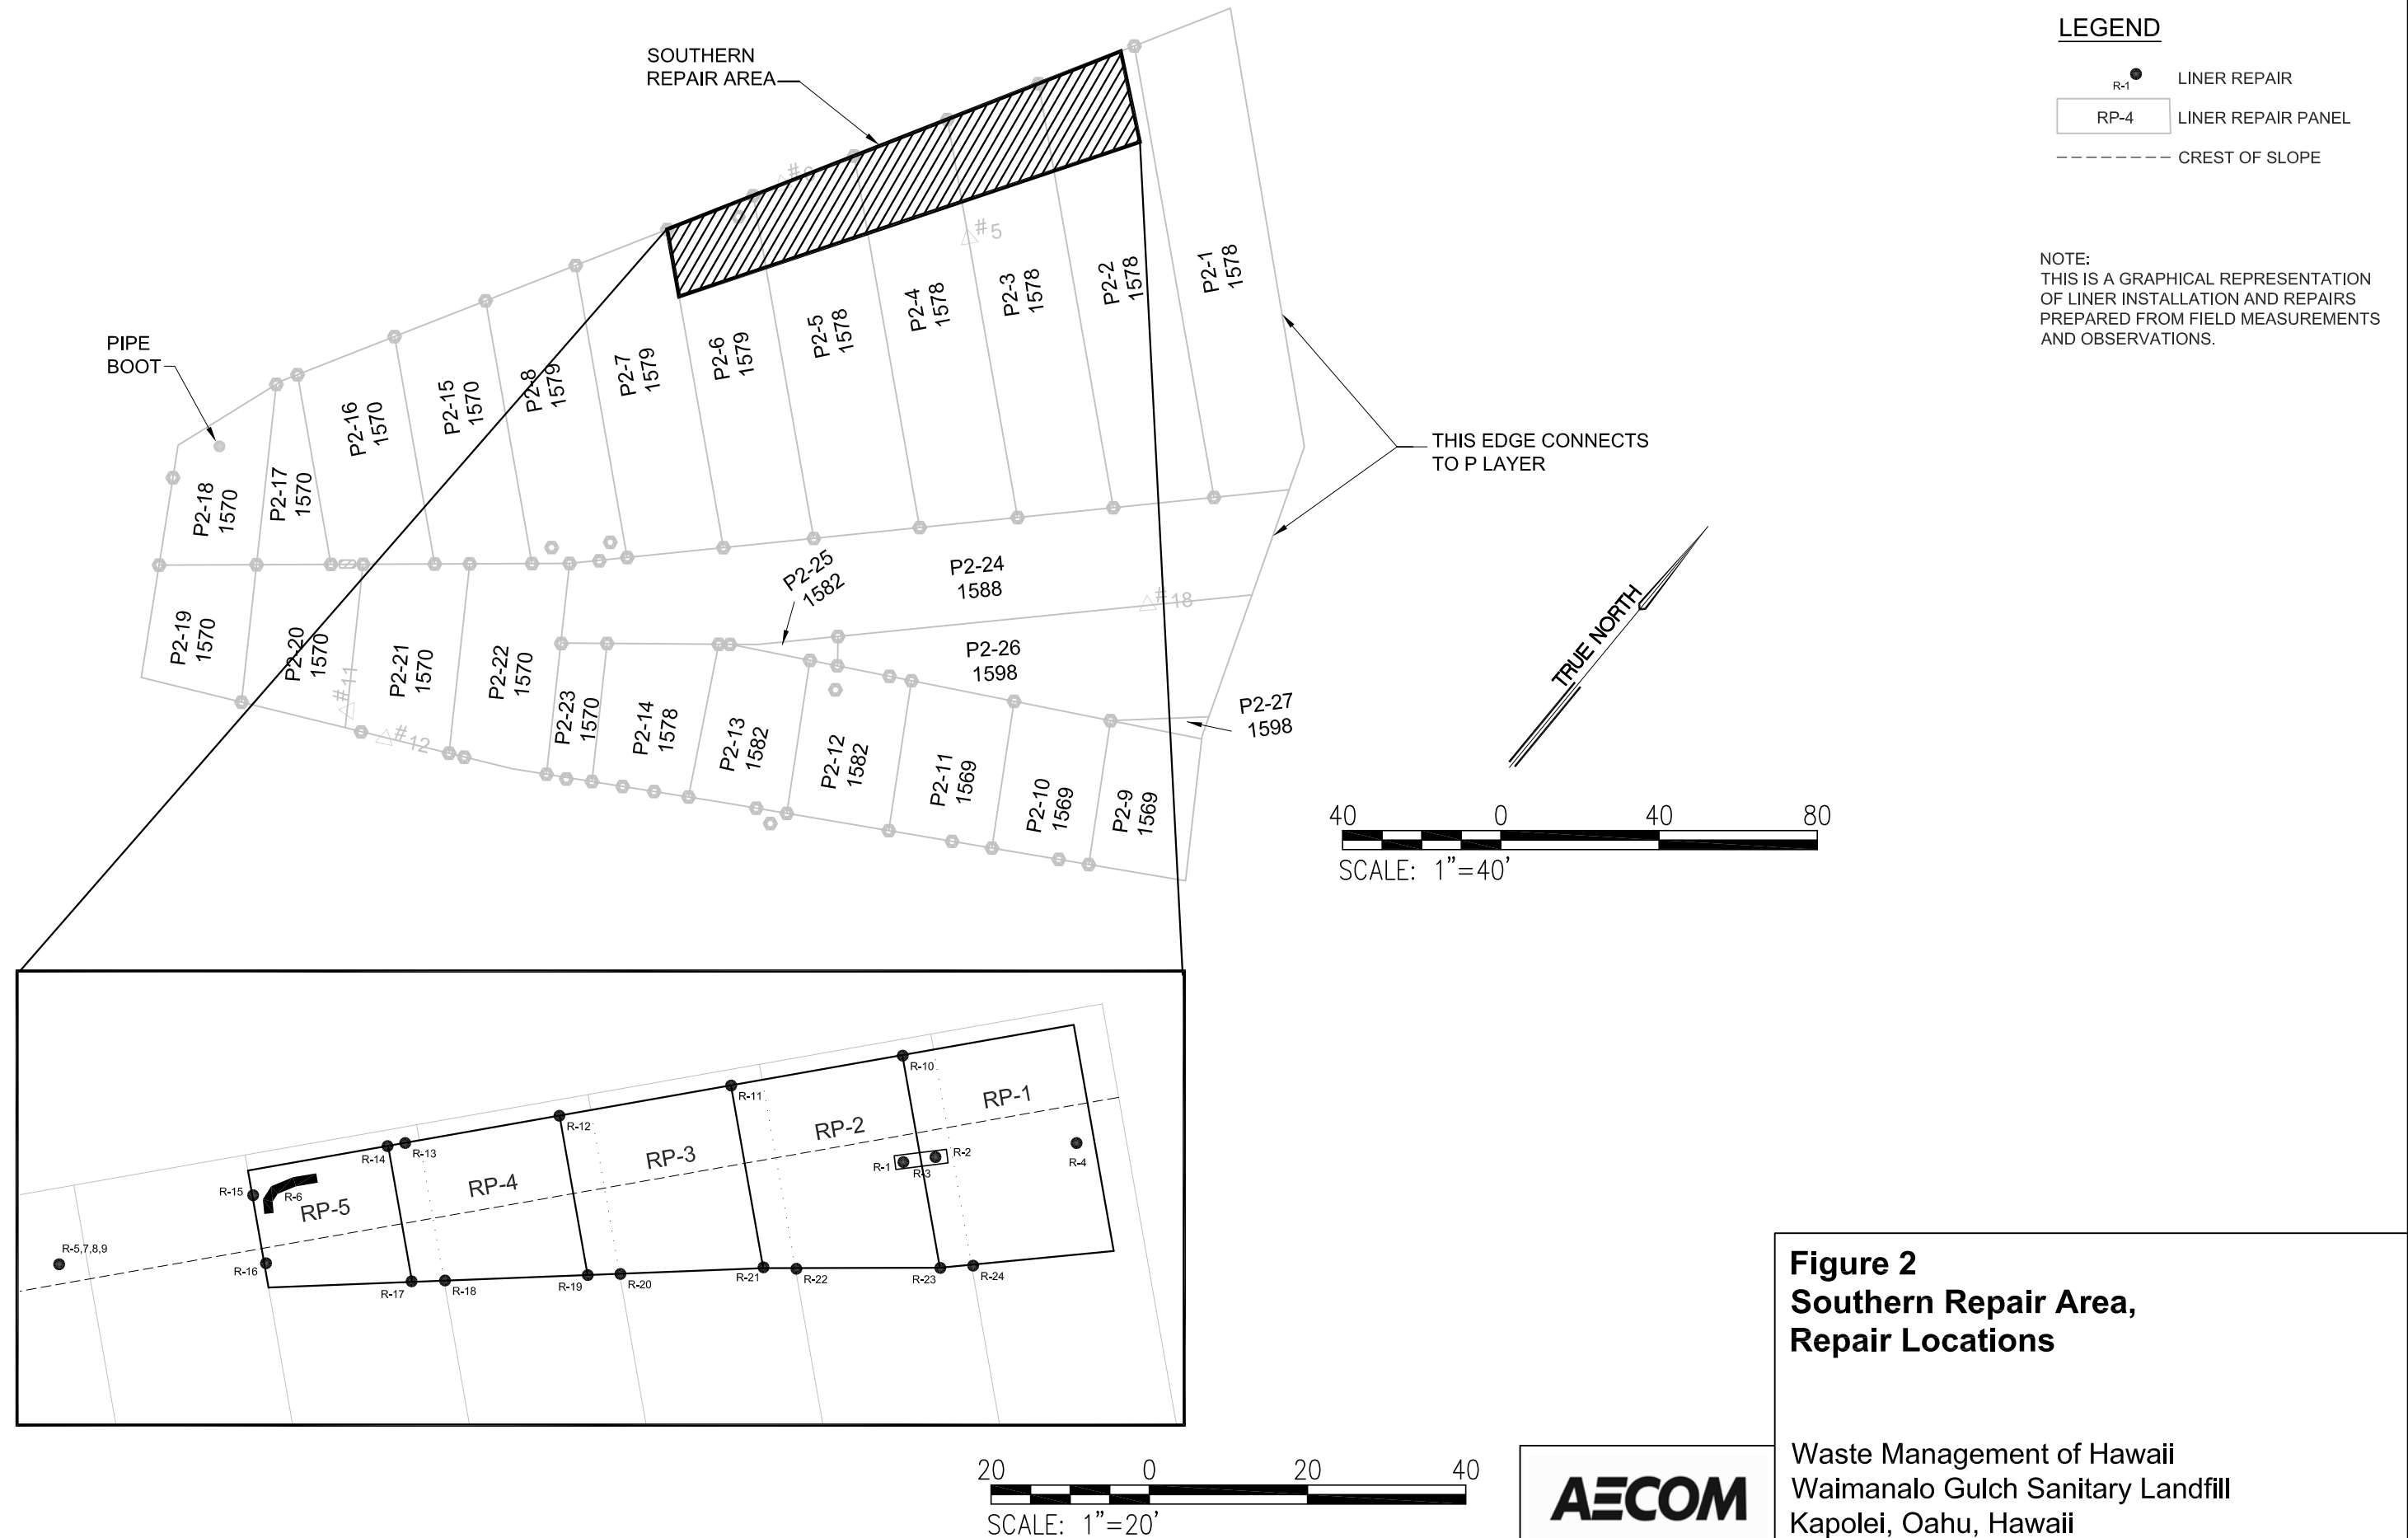
The repair areas and repair locations are shown on Figure 2 through Figure 4 in Attachment 1. The southern repair area is along the sideslope area of Cell E6, corresponding to originally installed panels P2-2 through P2-6 (60-mil panel numbers), and is approximately 130-ft long in the north-south direction and 20-ft wide in the east-west

direction. Only the upper 60-mil HDPE geomembrane was replaced in the southern area. The northern repair area is along the sideslope area of Cell E6, corresponding to originally installed panels P-17 through P-7 (60-mil panel numbers), and is approximately 190-ft long in the north-south direction and 45-ft wide in the east-west direction. Both the upper 60-mil HDPE geomembrane and lower 40-mil HDPE geomembrane layers were completely replaced in the northern area. Repairs to the geomembrane were made at locations where the liner was physically damaged during the storm events, in addition to areas cut to remove wrinkles, sediment, or hydrated GCL.

Hydrated or otherwise damaged GCL was replaced in the designated repair areas beneath the 60-mil HDPE geomembrane as shown on Figure 2 and Figure 4. The GCL was deployed in a manner not to entrap stones or other loose soil under the material. All adjacent panels of new GCL were overlapped a minimum of 18 inches and bentonite was applied at a rate of 1/4 pound per ft of seam. As it was necessary to remove hydrated GCL on the sideslopes, horizontal seams on the sideslope were required to complete the repairs. Request for Information (RFI) Number (No.) 26, approved the use of horizontal seams on slopes steeper than 10 horizontal to 1 vertical and required an overlap of 5 ft and gluing with 3M Super 77 glue. A copy of the RFI is included in Attachment 8. Horizontal seams installed during the repairs were completed in accordance with RFI No. 26.

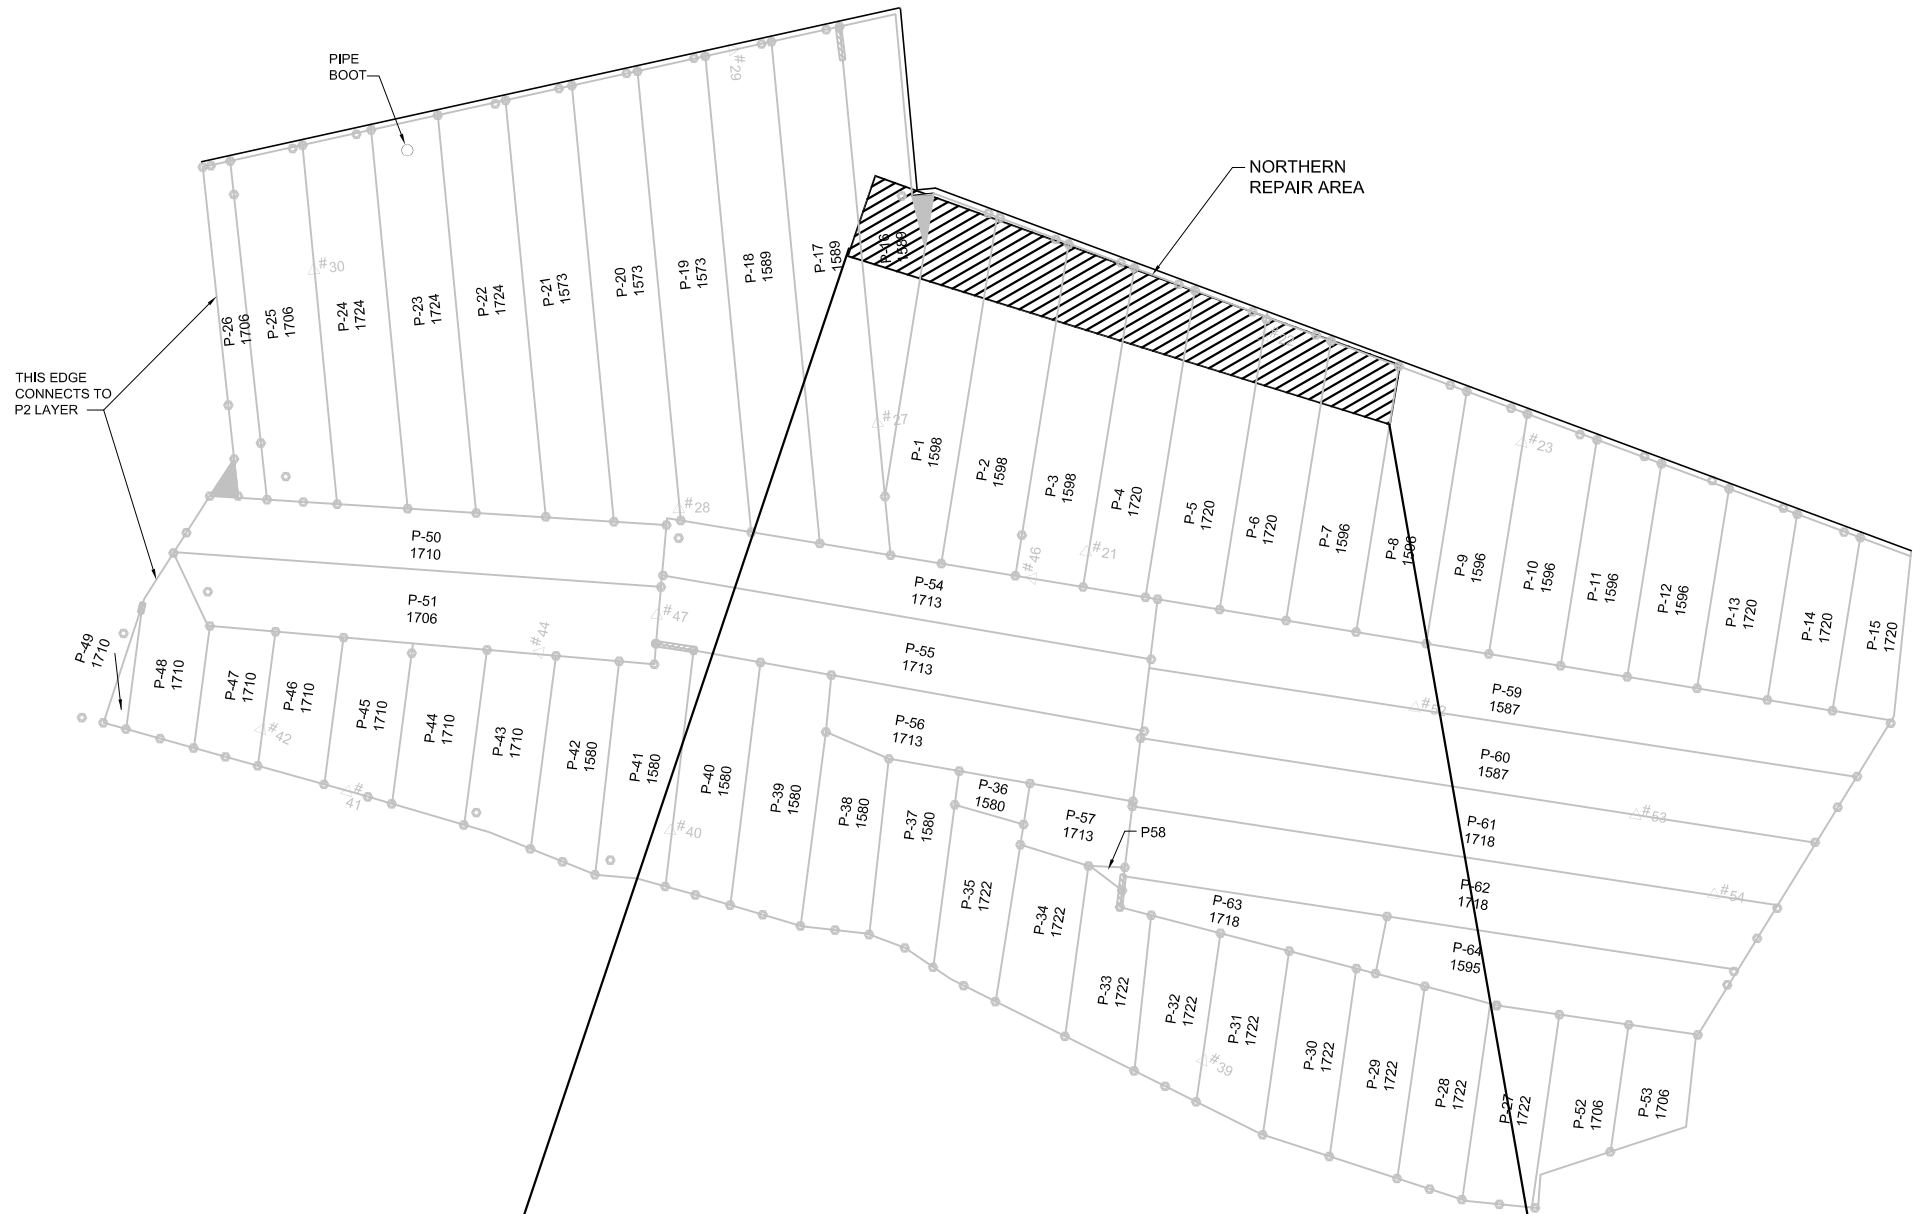
Figure 4
Northern Repair Area,
60-mil Repair Locations

NOTES:
1) THIS IS A GRAPHICAL REPRESENTATION OF LINER INSTALLATION AND REPAIRS PREPARED FROM FIELD MEASUREMENTS AND OBSERVATIONS.
2) NEW GCL WAS PLACED BENEATH THE 60-MIL HDPE GEOMEMBRANE REPAIR PANELS.

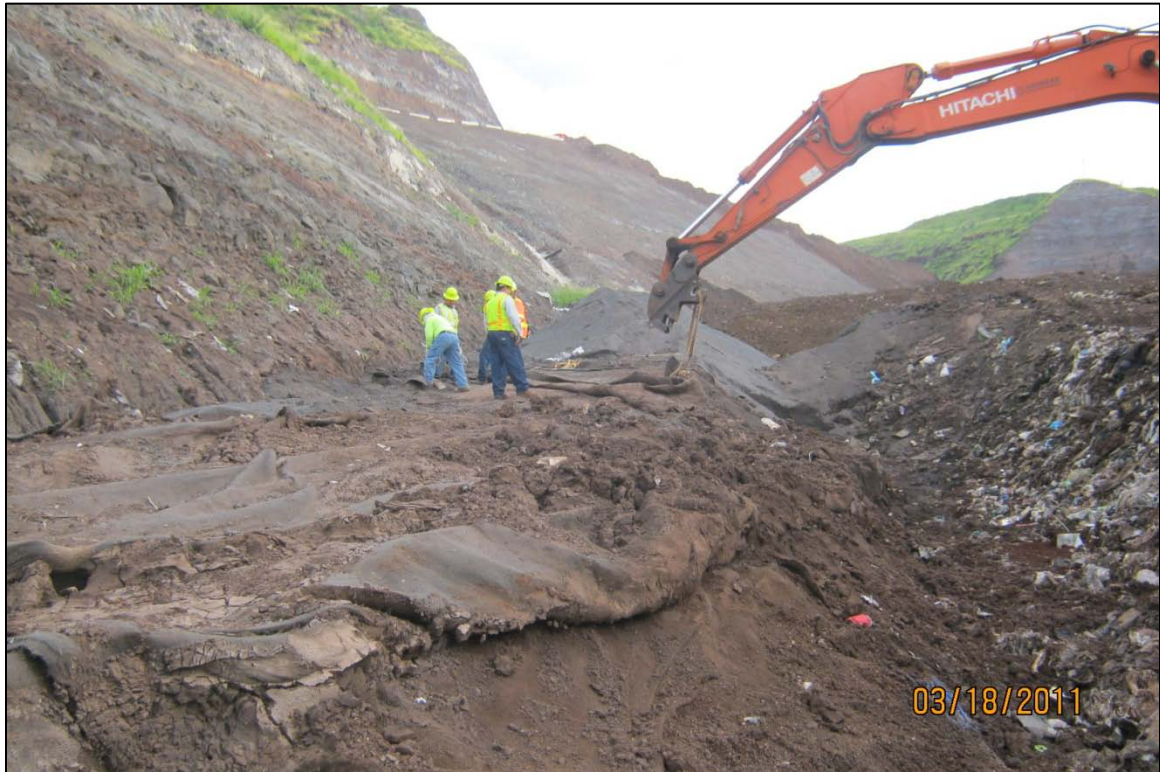
Photo 1: Removing 16-oz geotextile along the southern repair area to remove sediment, looking north.

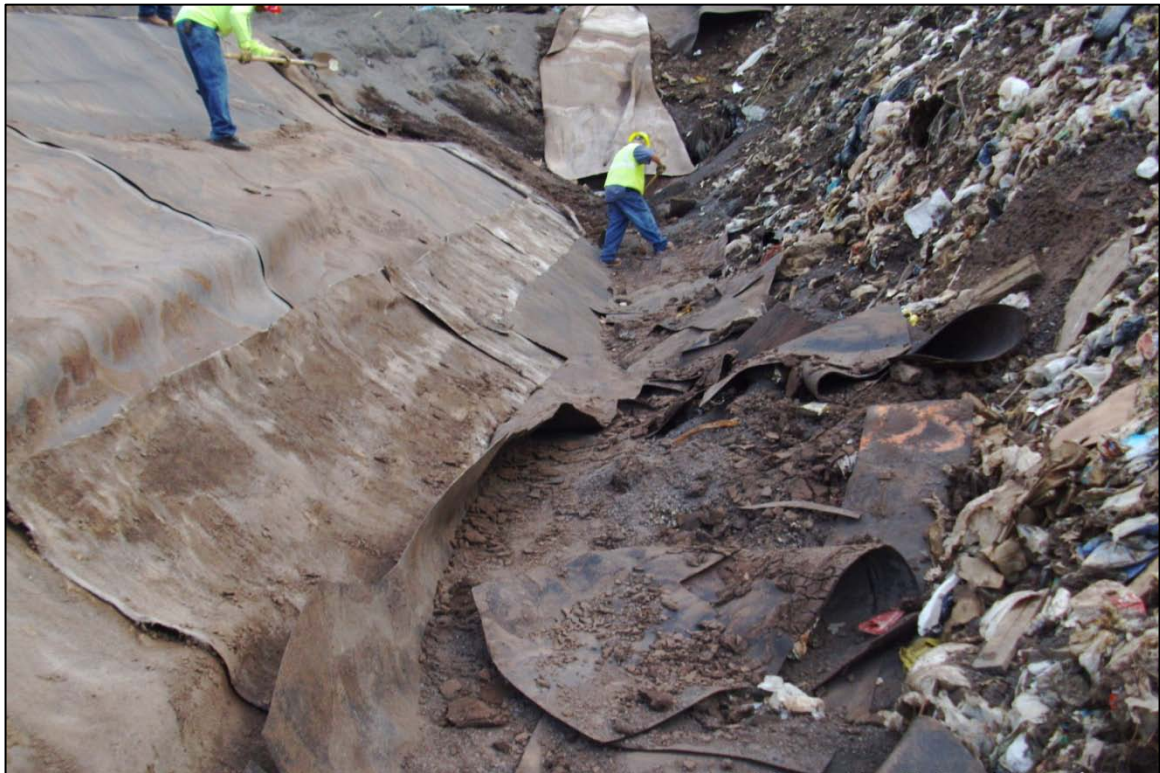
Photo 2: Exposed tie-in along the southern repair area, looking north.

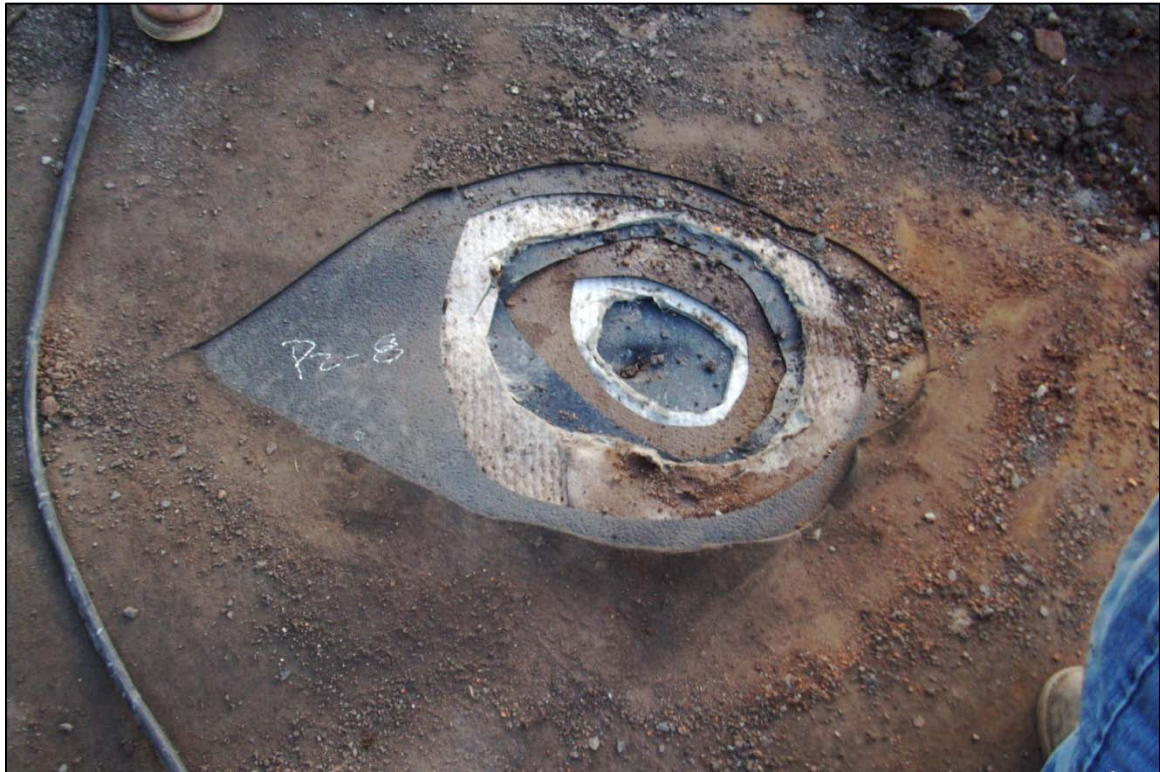
Photo 3: Inspection hole in double composite liner system to inspect lower GCL.

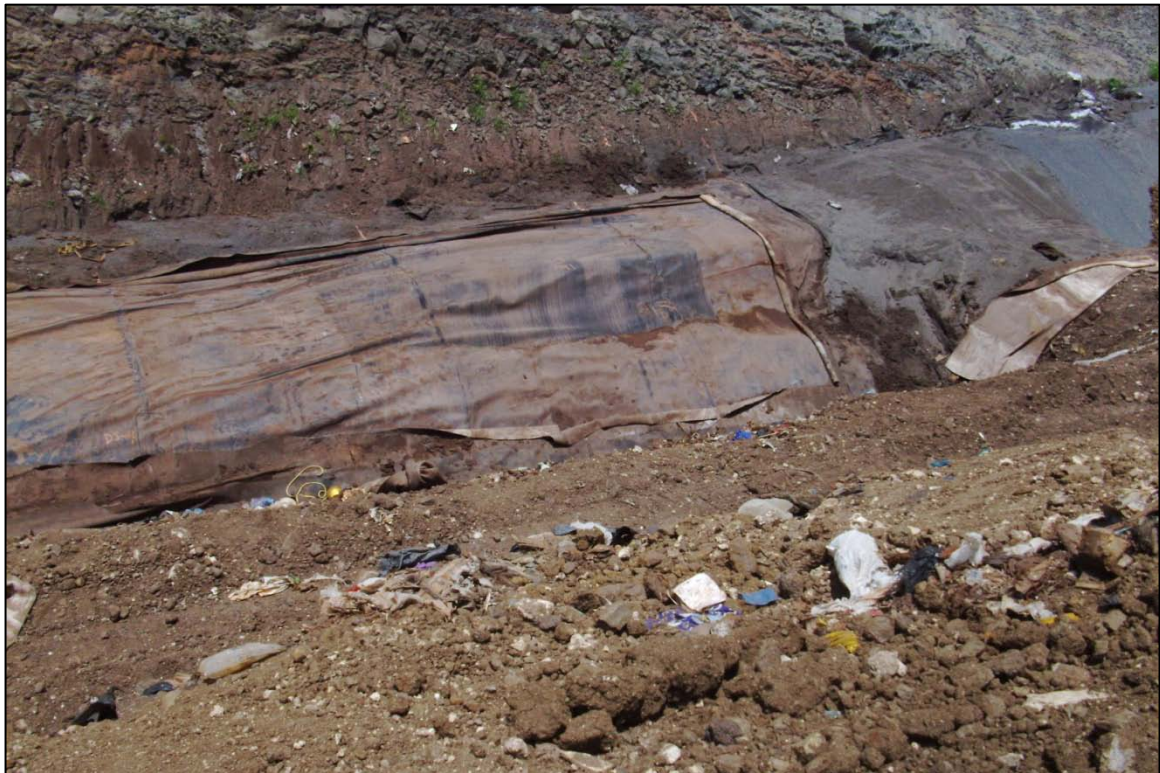
Photo 4: Overview of north section of the southern repair area following removal of sediment and the upper layer of GCL and 60-mil geomembrane.

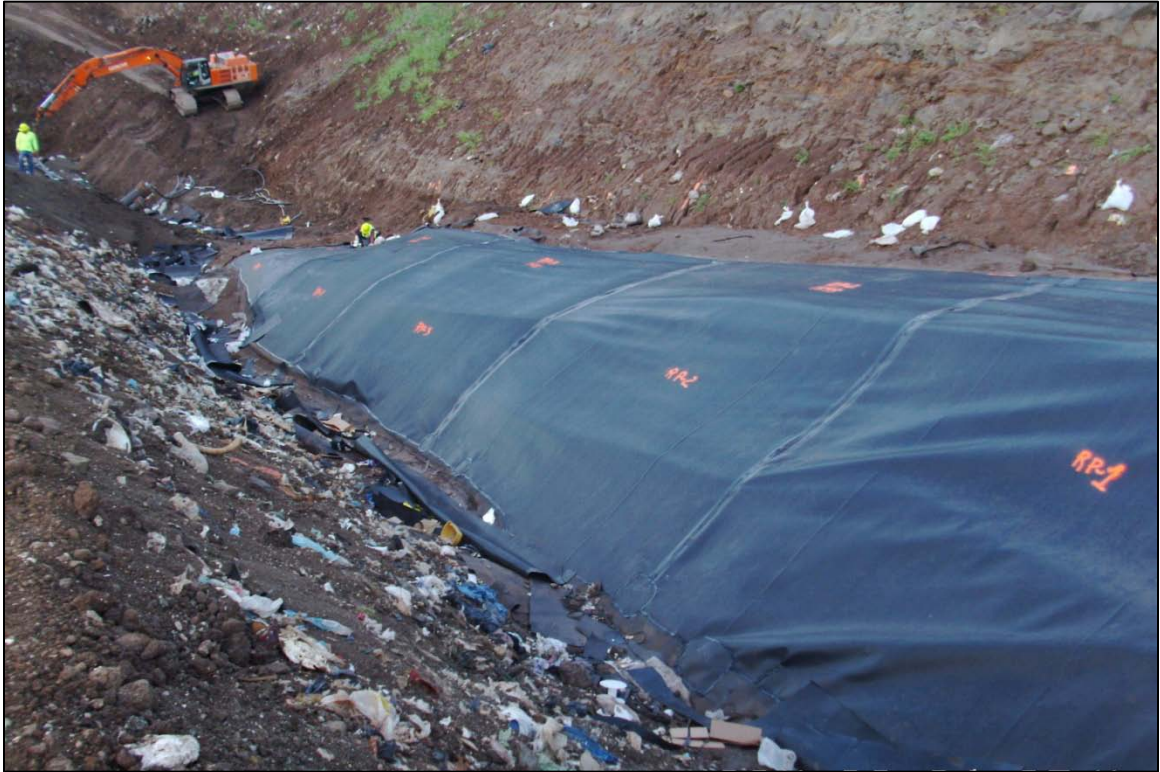
Photo 5: Southern repair area following replacing the upper GCL and 60-mil geomembrane, looking southwest.

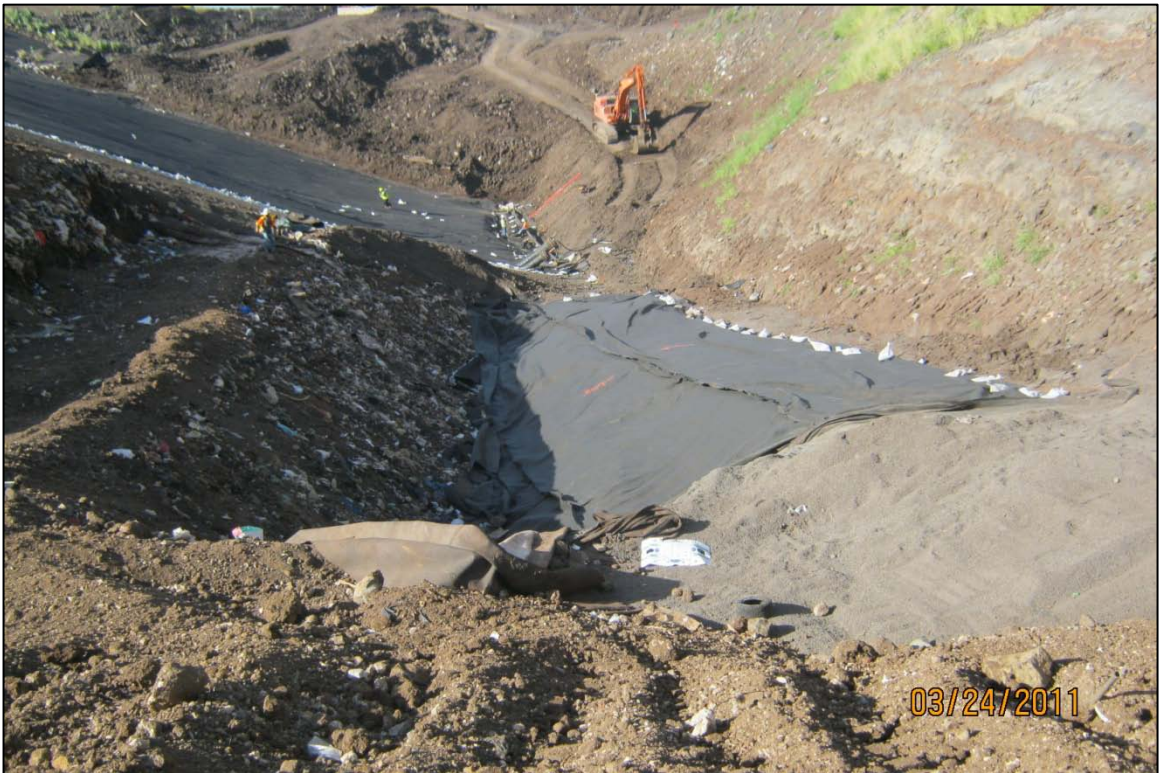
Photo 6: Southern repair area following placement of 16-oz geotextile, looking south.

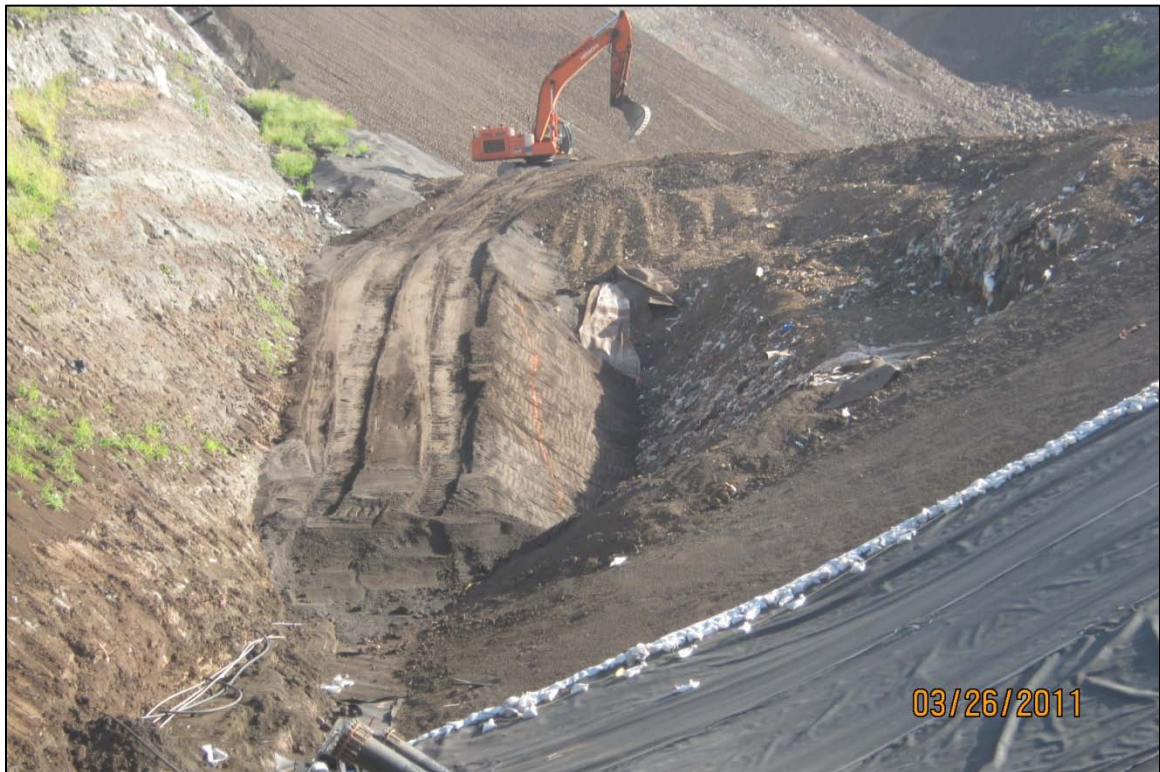
Photo 7: Southern repair area following placement of operations layer, looking north.

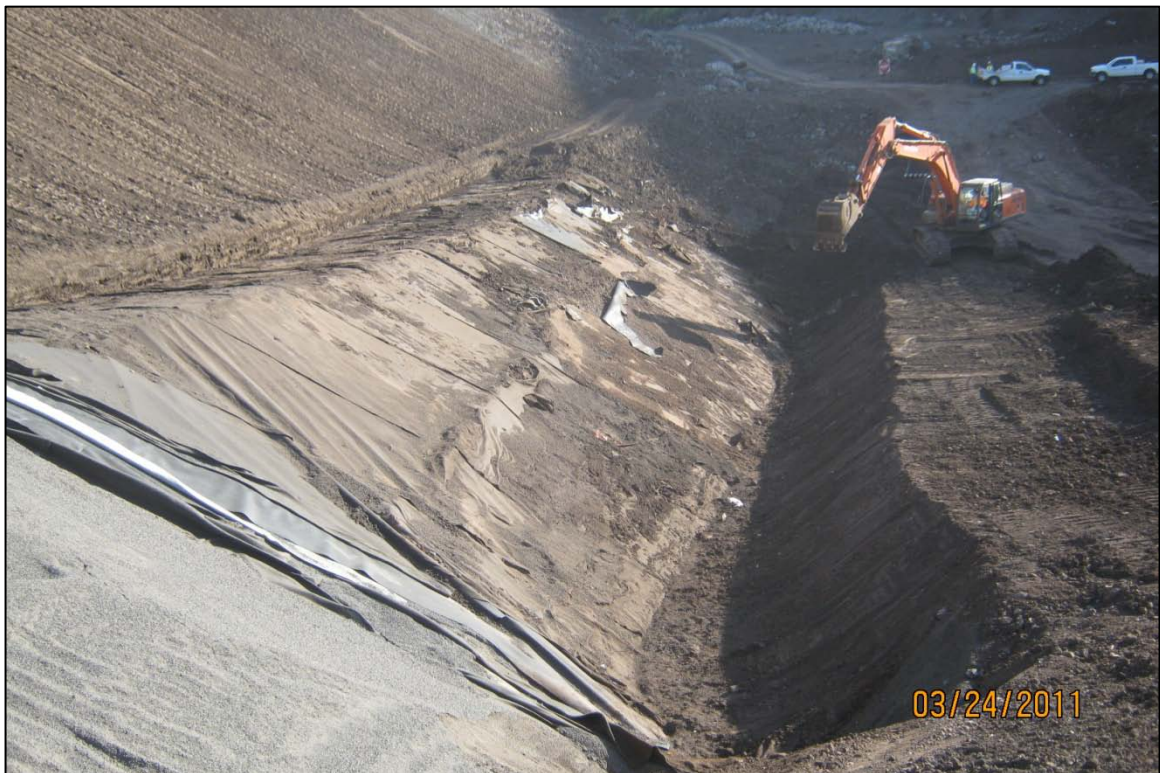
Photo 8: Northern repair area following removal of rocks and sediment, looking north.

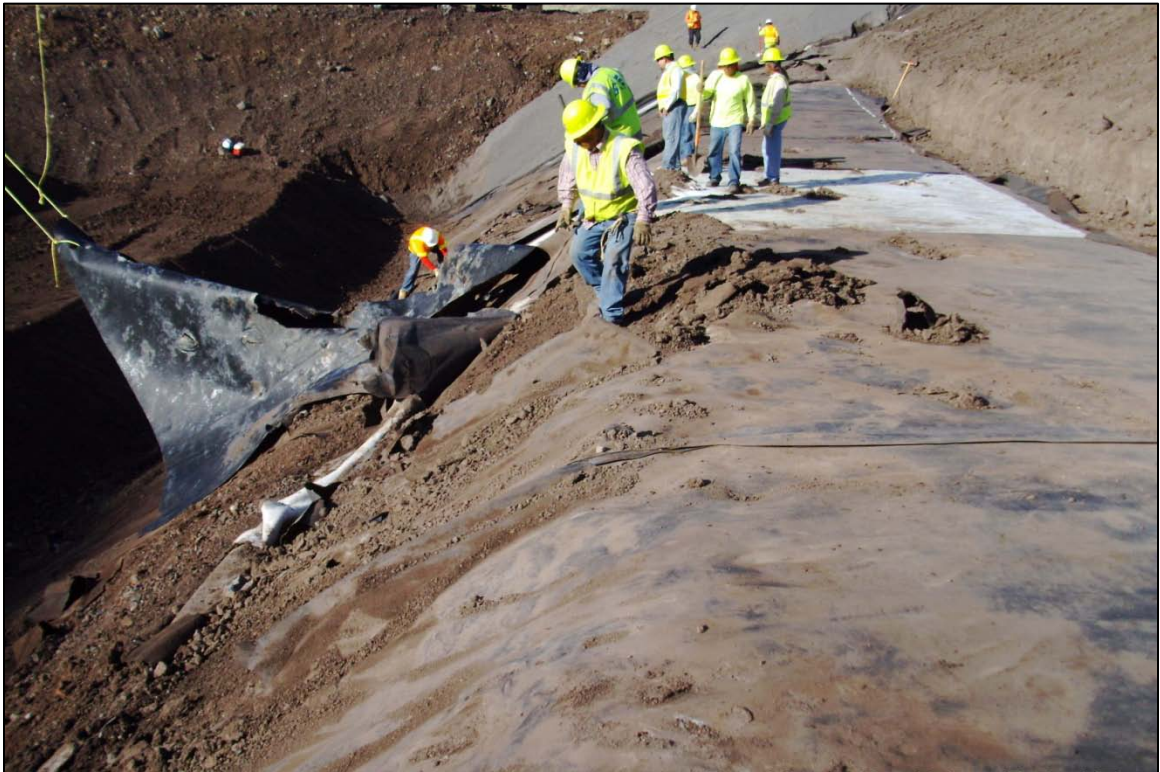
Photo 9: Removing 60-mil geomembrane in the northern repair area, looking south.

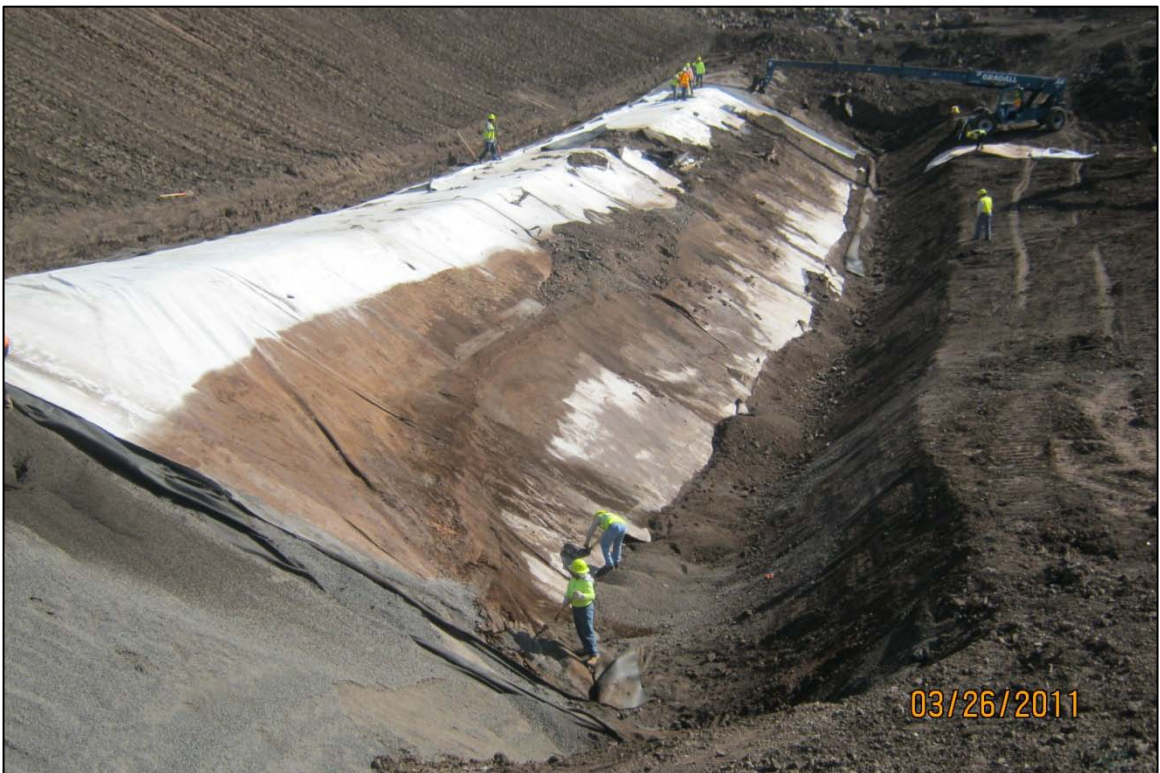
Photo 10: Line of sediment from storm event trapped above the GCL at the northern repair area, looking north.

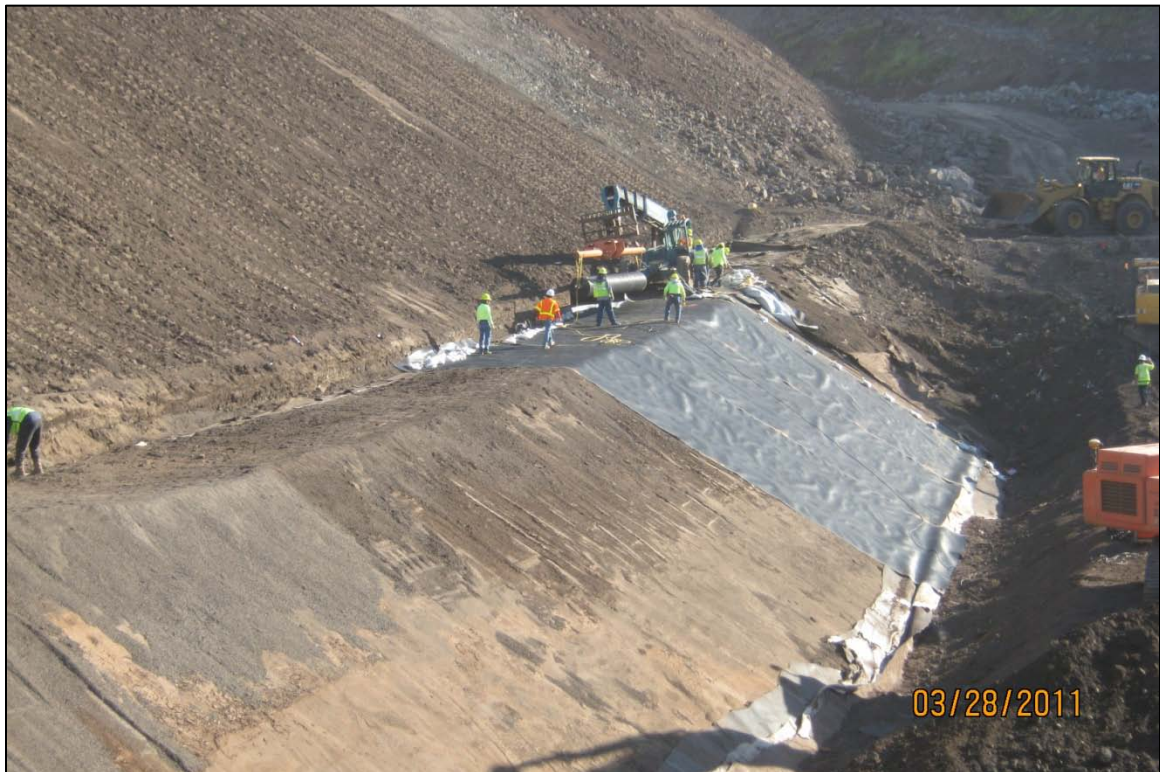
Photo 11: Deploying 40-mil membrane along the northern repair area following removal of damaged liner system and subgrade repair, looking north.

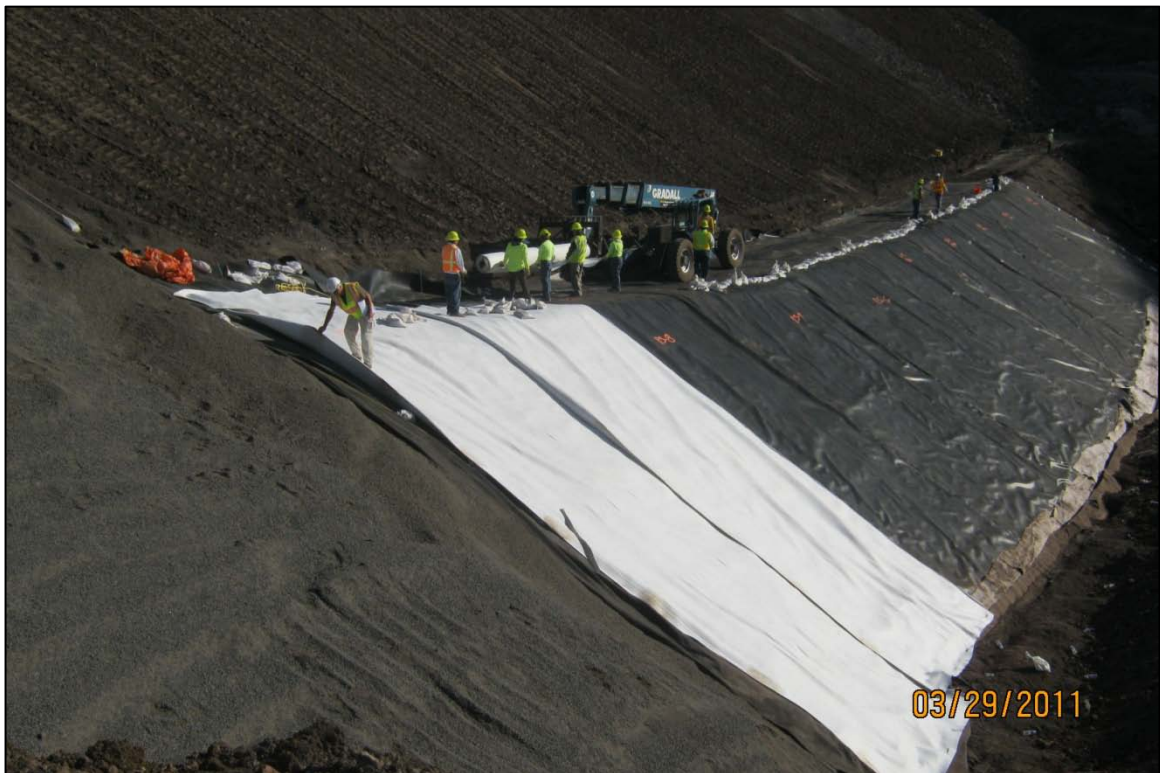
Photo 12: Deploying GCL over the 40-mil geomembrane along the northern repair area, looking north.

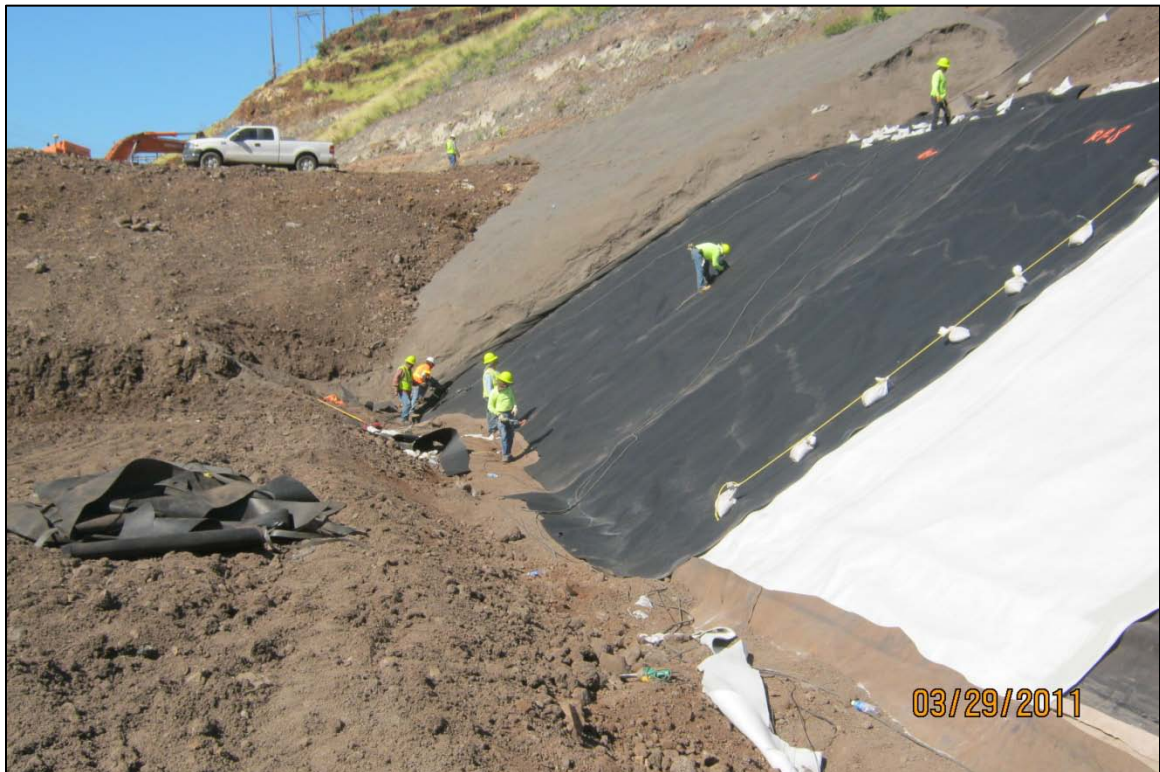
Photo 13: Welding 60-mil geomembrane panels and tie-in at the northern repair area, looking south.
